Post Fire & Debris Flow – A Lender's Perspective

Brandon Amyx
Senior Real Estate Administrator
Montecito Bank & Trust

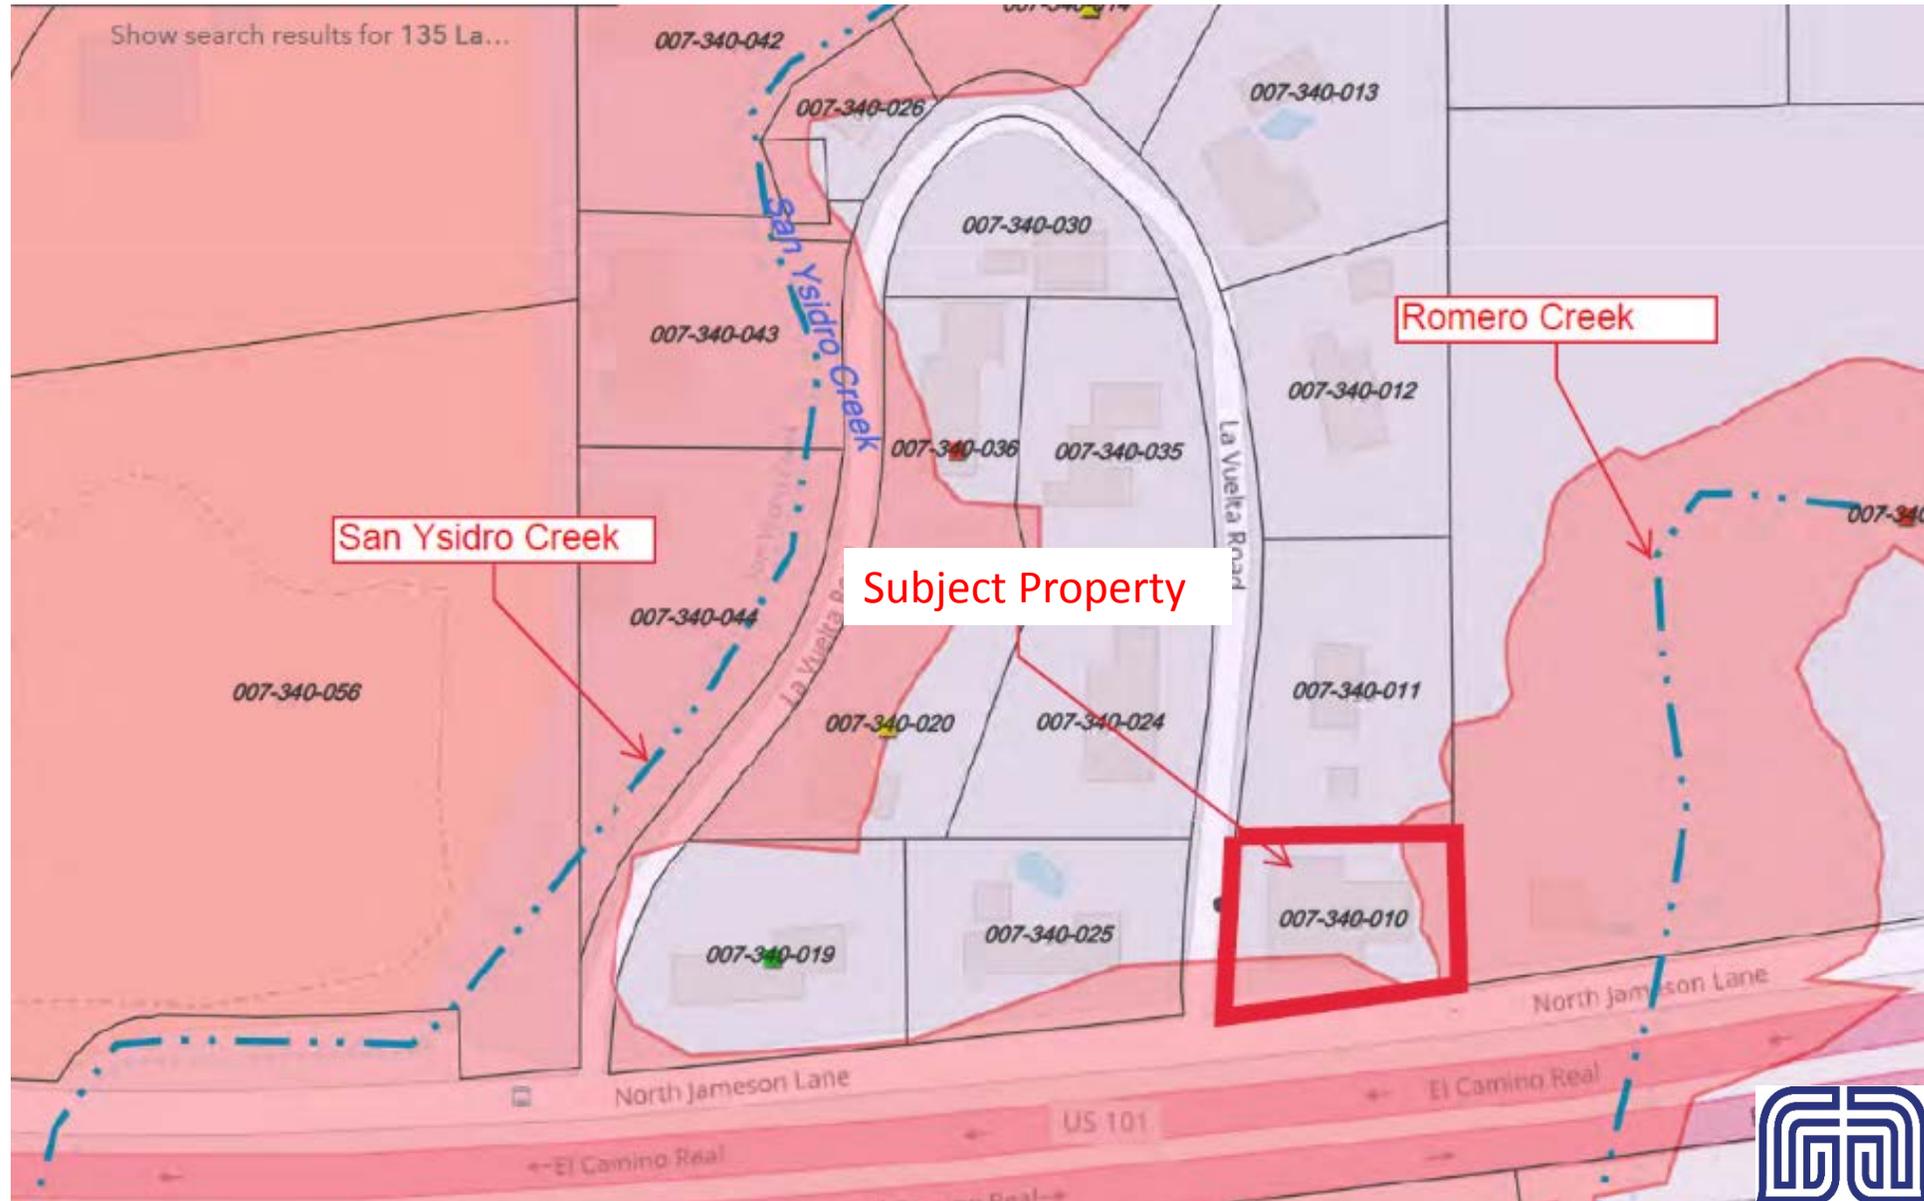
Mapping of January 9, 2018 Debris Flow by California Geological Survey

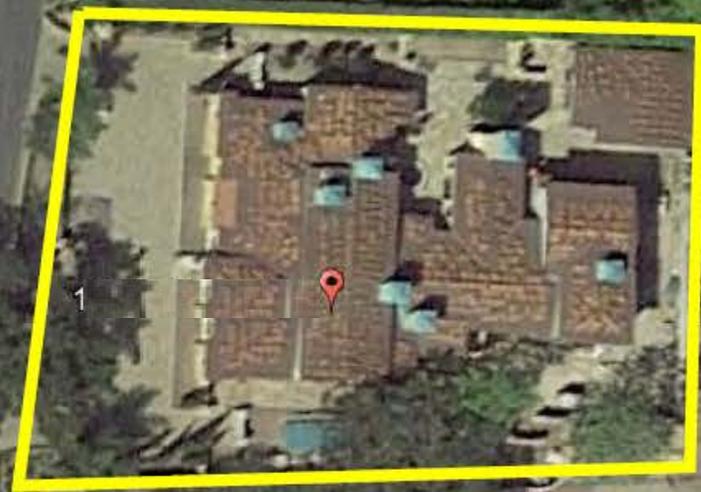
Romero Creek After Jan 9, 2018 Debris Flow

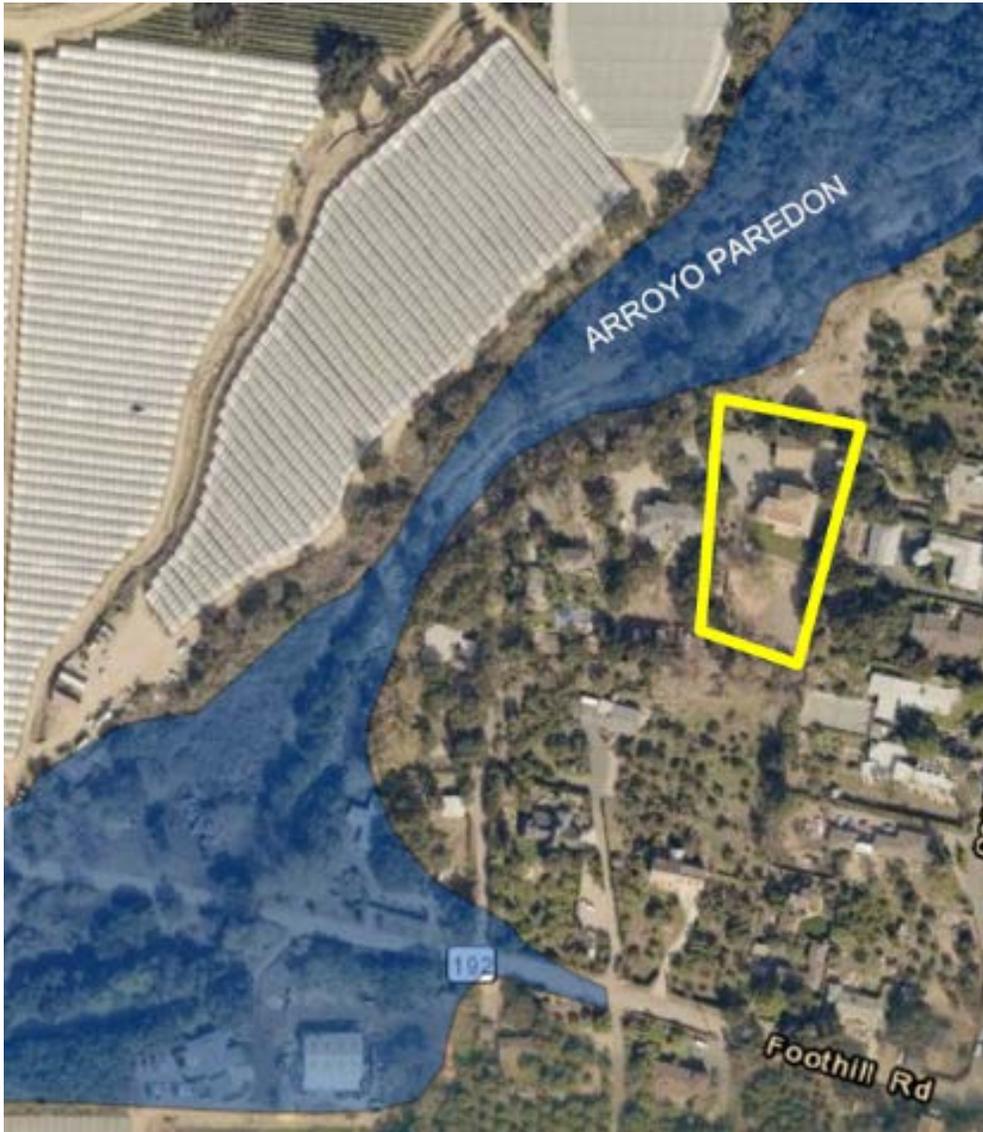
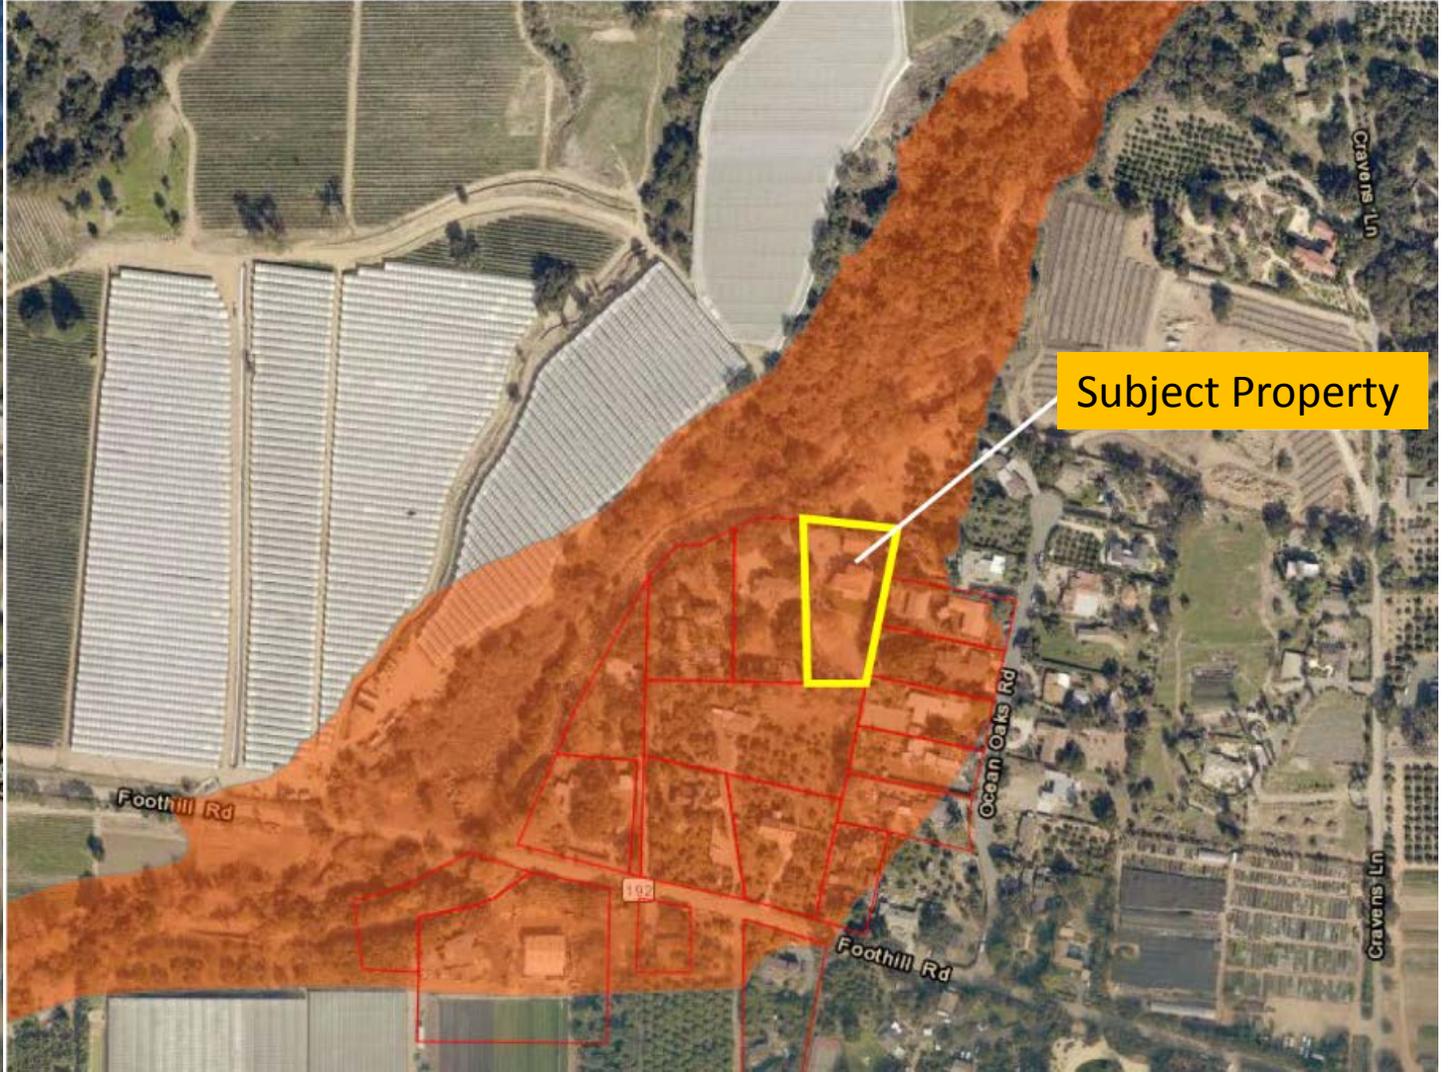
Santa Barbara County Planning and Development Debris Flow Risk Areas and Identified Parcels (12/03/18)

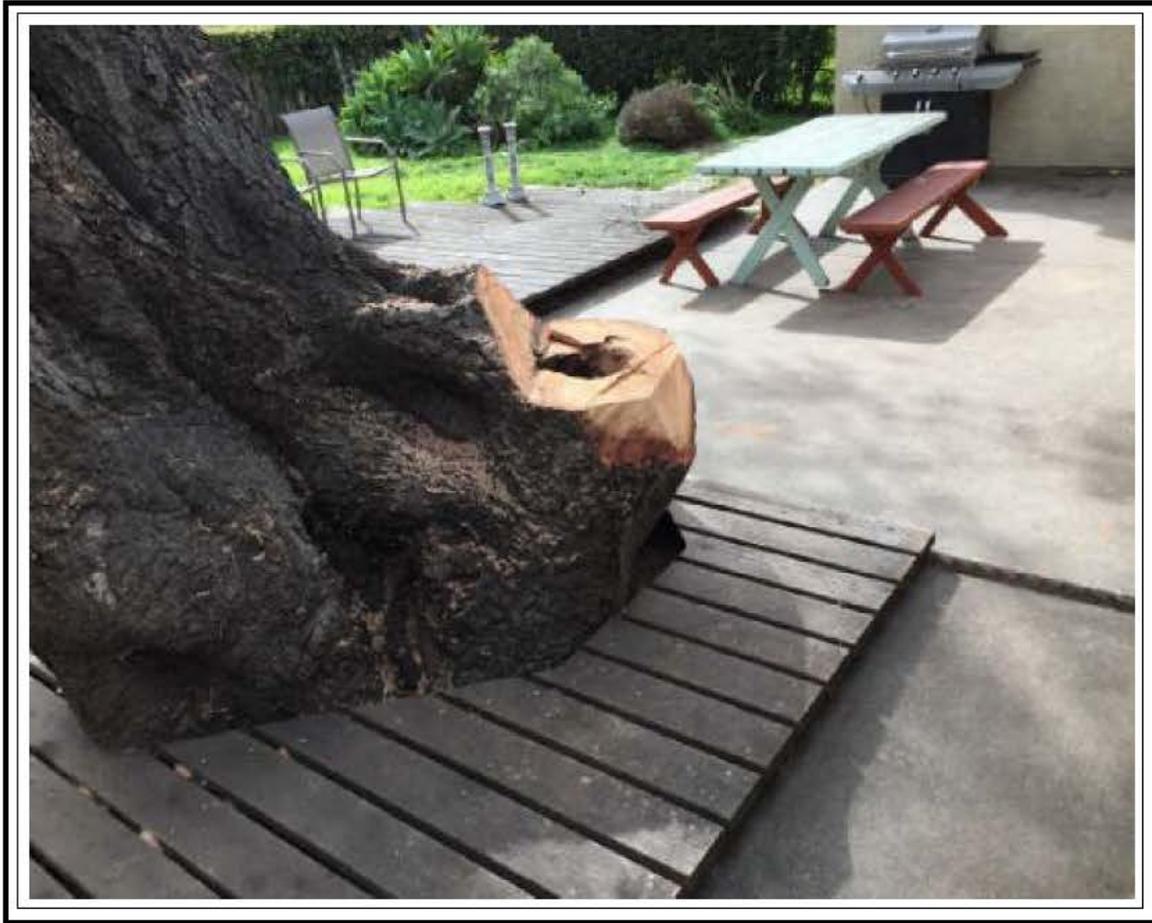
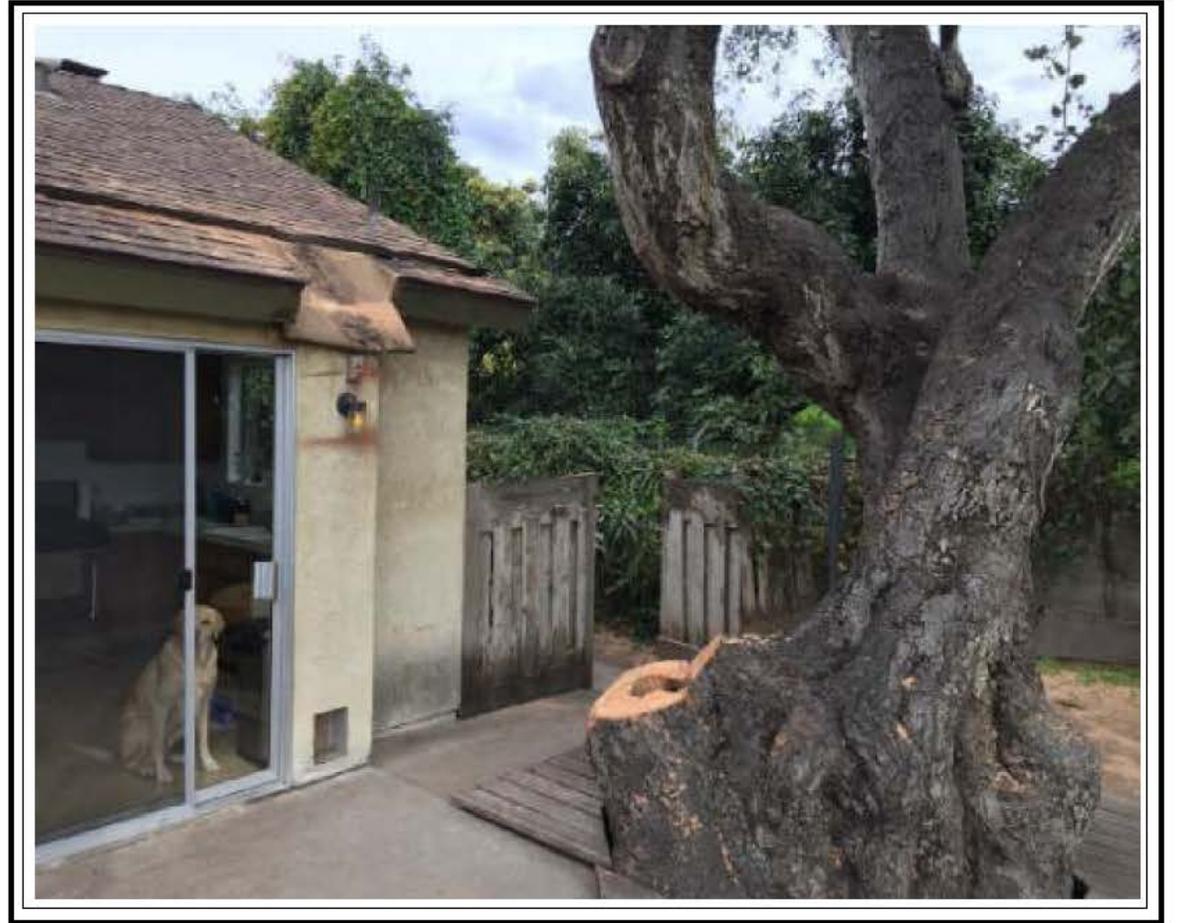
“The subject residence appears to have been built with a portion of the roof of the north eastern portion of the home (above the kitchen) allowing for the existing tree's large limb to encroach into the area where a roof/wall typically would have existed. Multiple substantial cables were noted throughout the rear yard, appearing to keep the tree from moving any further towards the residence. No evidence of structural damage or instability was noted. However, the appraiser is not an arborist, engineer, or contractor and should the lender have any further questions/concerns regarding the presence of the tree, the opinion/inspection by a qualified professional in these areas is recommended. No impact on marketability or appeal is expected due to the existence of the tree. See photos.”
